RE: Novato Sanitary District – Novato Wastewater Treatment Plant, NPDES No. CA0037958

Inspection Report

EPA Region IX and California Water Resources Control Board NPDES Compliance Evaluation Inspection (CEI) Report

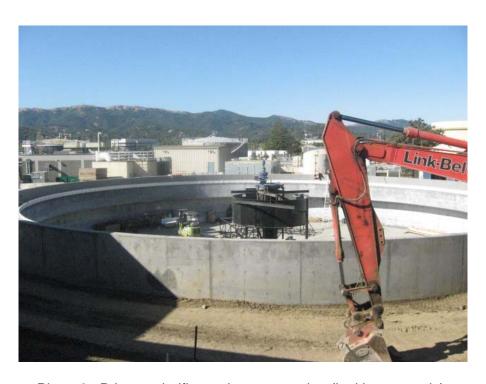
b. Permit modification received, if required, prior to changes. The Facility is in the process of a major reconstruction project (refer to Photos 2 and 3). New process units are brought online as they are constructed and tested. The Facility representative indicated that the Regional Water Board is notified when a new process is brought on-line.	N

Photo 2: Primary clarifier under construction (looking westerly).

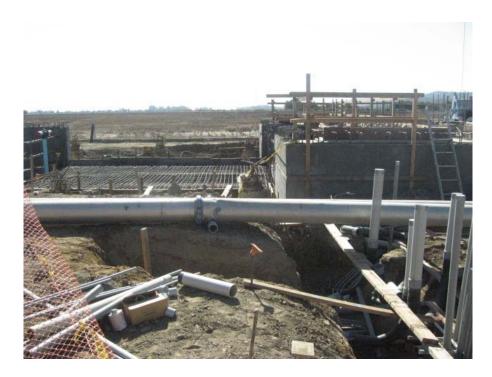
Photo 3: New disinfection unit under construction (looking southerly).

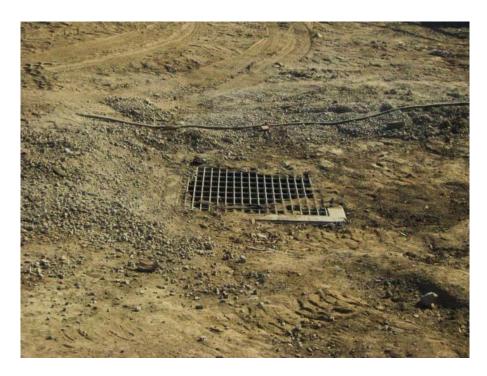
i. Other:	N
7g. Multiple storm inlets were found not to be protected from construction disturbance runoff (refer to Photo 4).	
8. Signs of tank deterioration and/or settlement.	S
Safety concerns are present that may interfere with proper operation, maintenance, and/or monitoring.	S

Photo 4: Site storm drain without protection. Drain chamber appeared to be completely filled with sediment.

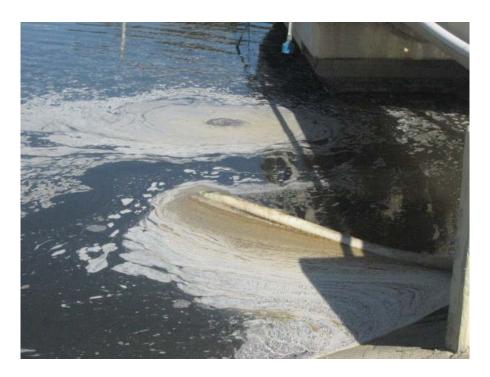
d. Excessive solids	S
e. Other:	N
3a. Scum and foam buildup were observed on the surface of the effluent pump wet well holding pond (refer to Photo 5) and on the surface of the chlorine contact pond. The Facility representative was unable to explain the presence of scum and foam.

Photo 5: Brown scum on surface of effluent pump station wet well holding pond.
